Roof Structure

Date: 20-Apr-2018

Report Commentary

1.0 Property and Site Built in: 2018 Address: Sample Address
Bedrooms: 3 Bathrooms: 2

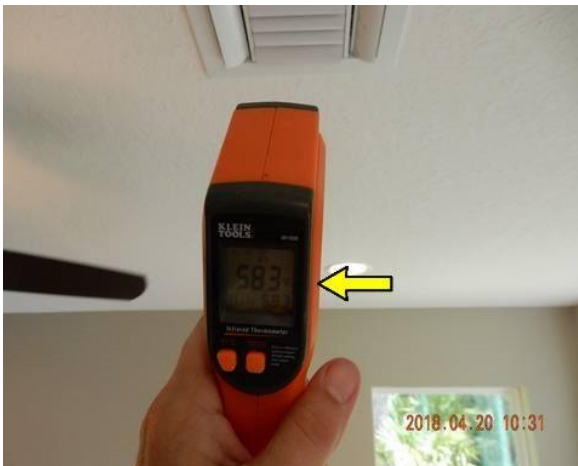
Supply Air Temperature: 58.3 Degrees F.

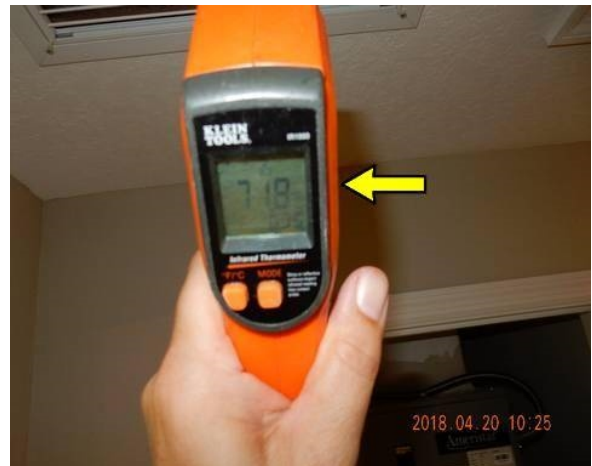
Return Air Temperature: 71.8 Degrees F.

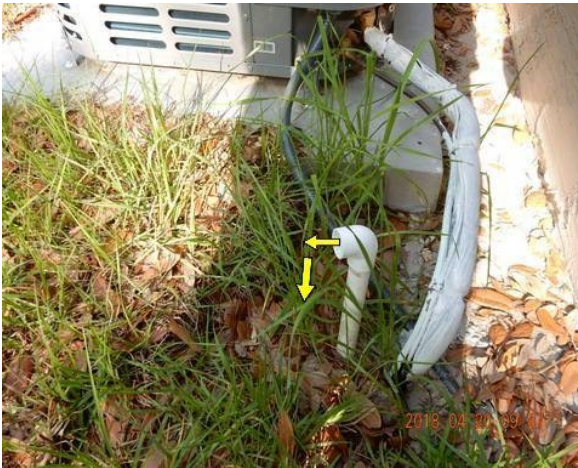
Condensate Line: Opening exposed to elements. Recommend that the open end be elevated and turned toward the ground to minimize potential for opening to be clogged and result in back to air handler.

Condensate Line: Exposed to misc. particles in the air.

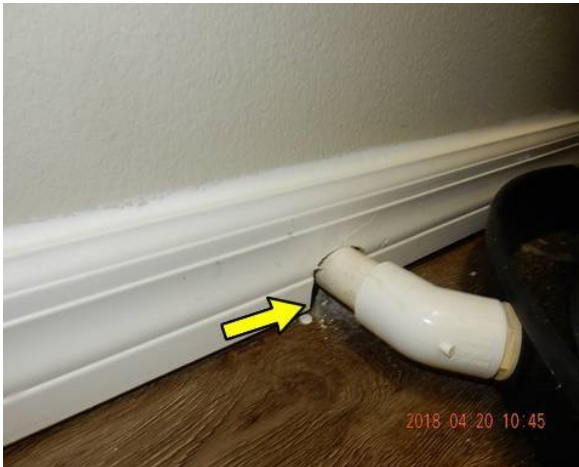
Laundry Room - Baseboard: Visible gap at the time of the inspection. Recommend that this be sealed to minimize potential for rodent entry.

Baseboard: Visible gap.

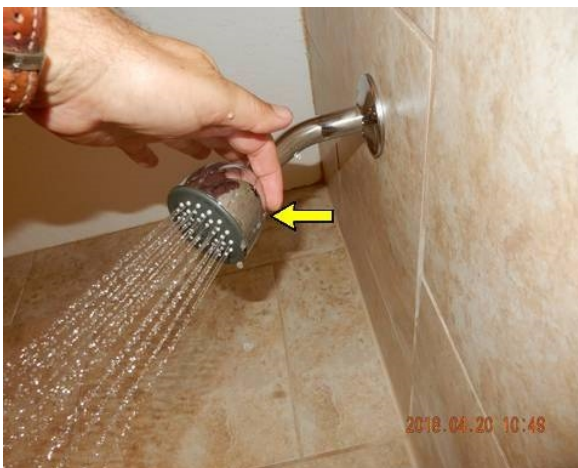
Main Bathroom - Shower Head: Visible, minor leak. Recommend repairing to minimize potential for moisture damage.

Main Bathroom - Shower Head: Visible, minor leak.
